First Choice Marine Technical Group

SERVICE ADVISORY

Number: 07-12-06

Through-Hull Corrosion

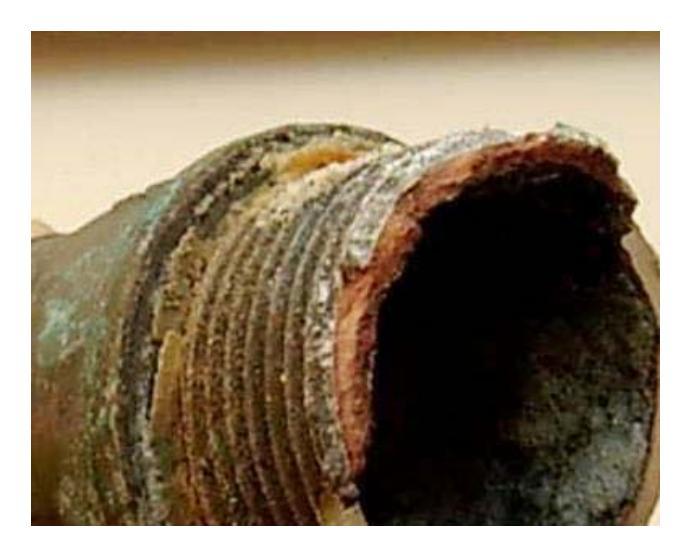
I have even had some technically analyzed by Lloyds in London to prove the material spec used in the manufacture. Every time the results came back that they were just brass which is not good for marine use. The problem with brass is it's just copper and zinc (often CuZn36 which is 64% copper and 36% zinc)

This is actually OK as long as you have a good zinc anode close by. But as soon as your anode is wasted away (remember they don't work once they are about half gone) then the zinc in the through hull takes over as the zinc anode and you soon end up with a weak copper that just crumbles away. (It is considered to have de-zincified when this occurs). Most of the zinc anodes are undersize so half way through the season its stops working and from then on the through hulls begin to corrode and quickly turn from brass to copper.

The thickness of the through hull is important as the thinner it is the quicker the corrosion penetrates right through. And of course everyone is saving money on materials so the thru hull fittings in the last 10 years are thinner than the ones we had 20 years ago.

The best quality for through hulls is Aluminium Bronze but that is very expensive so the production builders will not use. But adding a small amount of arsenic to brass increases its resistance to corrosion in seawater and is considered to be quite acceptable for marine use.

I can confirm that Group Beneteau changed to this marine grade just over 1 year ago so although we all need to still be on our guard and watch out for early corrosion on our existing boats, the new boats from 2007 should be much better and hopefully get through at least the charter life without failure.

The new material spec is CuZn36Pb2As. That means it has 2% arsenic.

So when replacing though hull we are now OK to buy from Beneteau or Jeanneau. These are made for them by Plastimo so we can buy them direct from Plastimo if easier. They have been designed specifically for Beneteau and the design is quiet distinctive so easy to identify.

- The inside of the flange against the hull is recessed for using a sealing ring instead of sealant
- - the inside at the top is a hexagon shape for a special tool to stop it tuning as it is being fitted

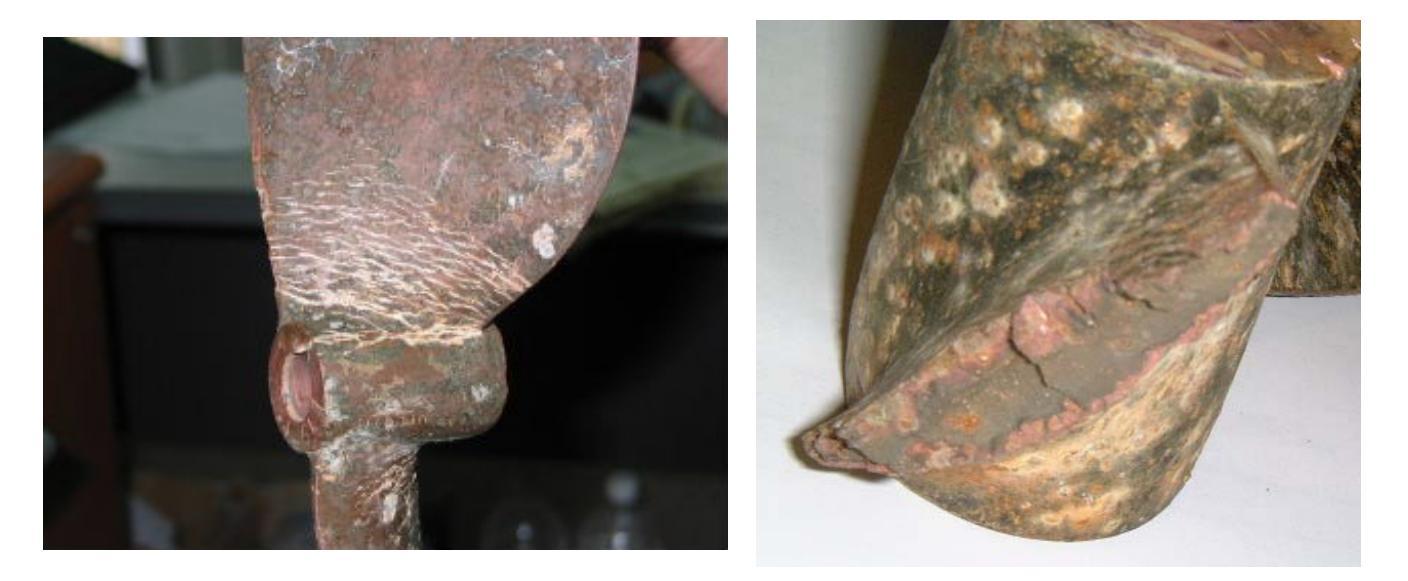
In recent years we have also seen our propellers corroding. It is almost certain they are also made of brass. However with the shaft nut zinc is so close they should be well protected. But again only if the zinc is effective.

The photos below show the copper red color of de-zincified brass. The corrosion is so deep that the surface of the blade is cracking just prior to the blade falling off. The 2^{nd} photo shows the blade broken off and you can easily see the depth of the corrosion.

Testing the prop is easier

Just dig a small groove in the surface with a knife, file or small grinder and check how deep you have to go through the red de-zincified material before you get to bright yellow brass.
